# FACILITY COMPLIANCE INSPECTION REPORT

# Division of Waste Management Solid Waste Section

Date of Site Inspection: June 25, 2012 Date of Last Inspection: January 11, 2011

Fort Bragg Closed MSWLF Longstreet Road, Fort Bragg

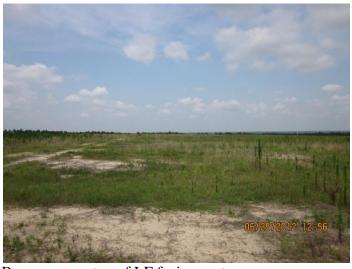
- 2. There was minimal erosion occurring in one area near the eastern perimeter of the landfill. Please repair this and any other areas that were not visible during the audit to mitigate further damage to the cap.

Bare areas on top of LF facing east.

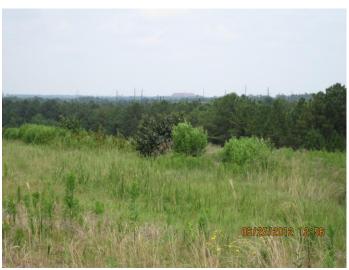
- 3. Small trees were observed growing along surface drainage features that are over waste. Please remove all potential deep root penetrating trees and shrubs as they are observed.

Trees growing over waste facing south east.
